# Neofit Case Histories from Europe

## **Neofit Case Histories from Europe**

### Report

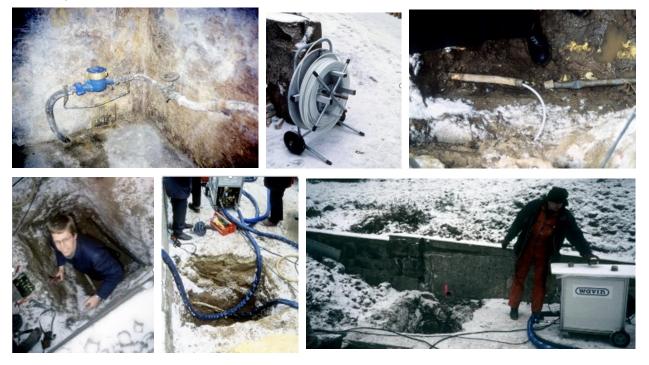
Some impressions of the installation:

The <sup>3</sup>/<sub>4</sub>" (OD 32mm, ID 21mm) lead service pipe to a house in the Bannewitzerstrasse in Freital was used as a demo with Neofit for local water supply company Trinkwasserzweckverband Weißeritzgruppe (WVW)

The service pipe with a length of 15m was located between the main in the street up into the cellar of a four family house 5m higher. The pipe was cleaned rinsed & dried with foam plugs under air pressure. A Neofit tube of 10mm was easily inserted without any problem. Even although the weather conditions were harsh because it was snowing at an ambient temperatures of  $-4^{\circ}C$ , the expansion process went very well.

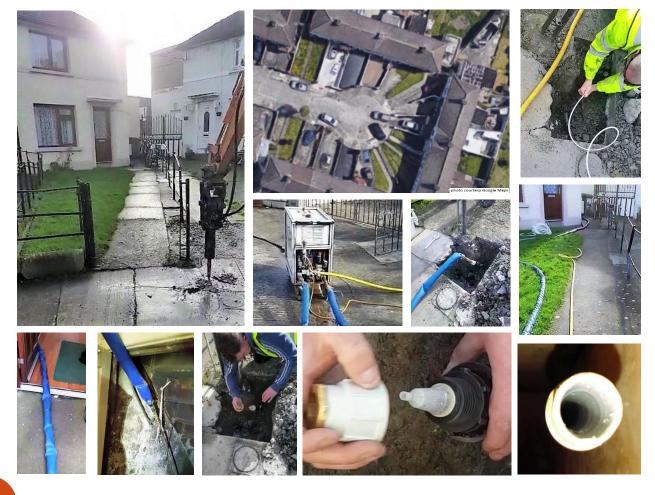
Impressions of the lining work:

In February 2017, DCC, in a joint effort with Irish Water, wished to try out the Neofit<sup>®</sup> system and approached the installation company All-Brite Environmental Ltd from Kilrush for this. The lead services of two houses in Cabra, Dublin 7, were lined. Both were ½" in diameter and each 16 m in length. For the lining 7mm Neofit pipe was used.
