Neofit[®]+Plus

Expandable Pressure Pipe

Neofit® (Virgin PET: Polyethylene Terephthalate) is a cost-effective, trenchless, non-invasive, semi-structural piping system for existing water service lines. Neofit® helps maintain the existing service pipe by creating a barrier inside the existing pipe, not by replacement. The Neofit pipe protects potable water in existing lead or copper service piping, extends the existing service pipe's life, or can seal leaks and pinholes. Because of the smooth PET material of the pipe, flow capacity is not negatively effected. **Designed for ½” to 2” ID and up to 300ft sections.**

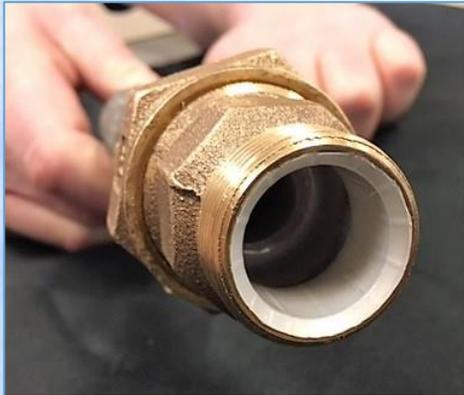
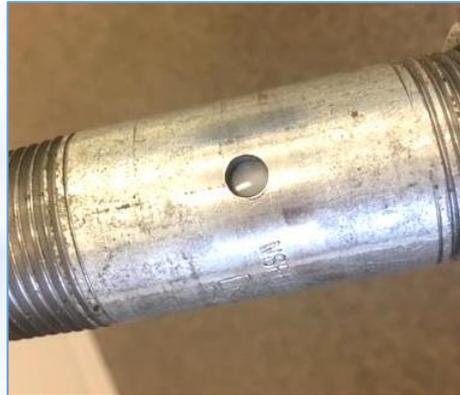
The Neofit expandable pressure pipe comes in rolls of:

7mm - ½”

10mm - ¾”

15mm - 1”

20mm - 1-1/2”+

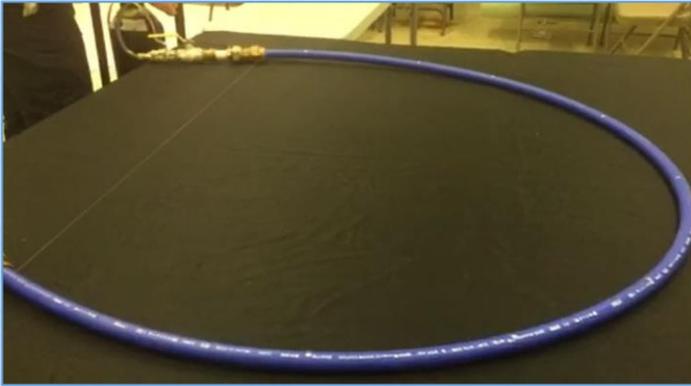
1) 150psi Leak Test

Neofit® installed in PEX tubing with 3/8 inch holes in the PEX every 8-12 inches. The fittings used were compression style with the Neofit® pipe flanged at each end. This would represent an extreme leaking water service lining installation. The Neofit® lined pipe was pressurized to 150 psi and held for 48 hours with no leaks

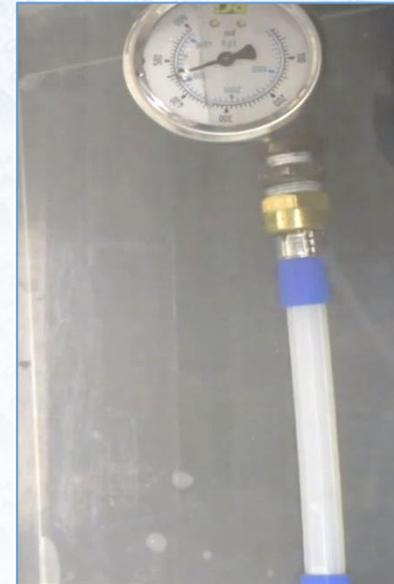
2) 460psi Burst Test, Expanded Stand Alone

Stand-alone Neofit® burst test as per ASTM D1599 for pressure testing of structural piping. The stand-alone Neofit® burst at 460 psi. Neofit® is not intended to be a stand alone pipe, this test is merely to prove the strength of the pipe material.

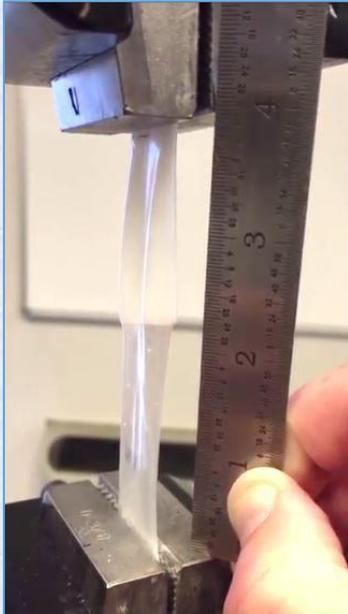
3) Expanded Stand Alone Neofit® Stretched: Doubles Length

Tensile test of 10mm Neofit® expanded to 3/4" pipe size. Results show a 2" section was stretched to 4" without any tearing or damage to the material. Again, this test is to prove the strength of the Neofit material

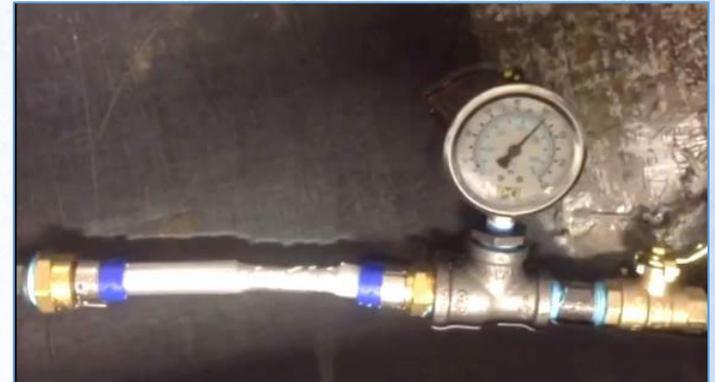
4) 105psi Burst Test, Expanded & Stretched Stand Alone Neofit® Under Pressure

Stretched and stressed 10mm Neofit from previous tensile test was capable of holding up to 105 PSI before bursting, as per ASTM D1599.

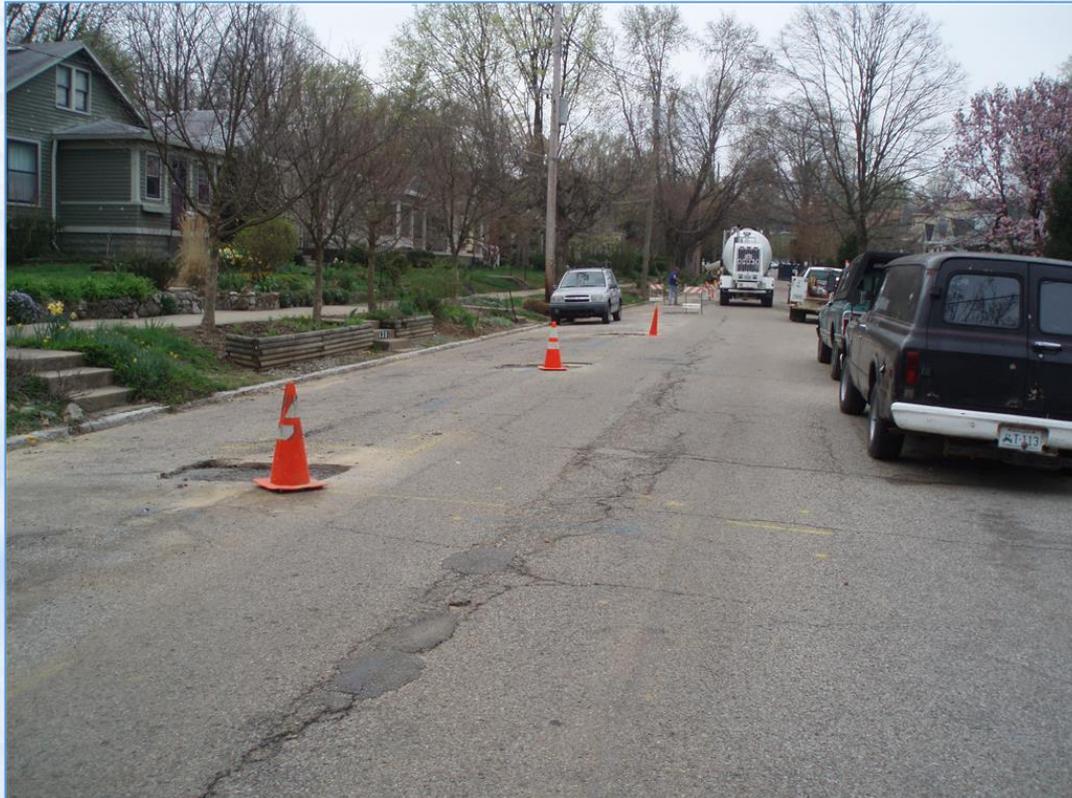
Neofit Case Studies-Louisville

Example of Outliers - Taking note of the 2520 job site, there is clearly an issue here. Seeing as it appears an outlier to the other results, it was investigated further and it was discovered that there were lead contaminated brass fittings used. After replacing the fittings, the lead level significantly dropped to similar levels as the other locations.

* Note: 4/3 and 4/5 sample events for 2520 Meadow determined to have been contaminated by lead from original brass fitting. This fitting was replaced for the 4/14/16 sampling event.

While Neofit® provides a complete barrier, it must also be paired with proper fittings. All connections must be lead free, as 2520 Meadow Rd demonstrates (Louisville). This situation is not a Neofit- only issue, same goes for any other type of rehabilitation. If any scale/sediment were to get into the pipe during installation, it would simply be flushed out during the first flush. Any traces of lead afterward would be due to the water being in contact with contaminates from the main or lead fittings/appliances elsewhere, not the PET pipe.

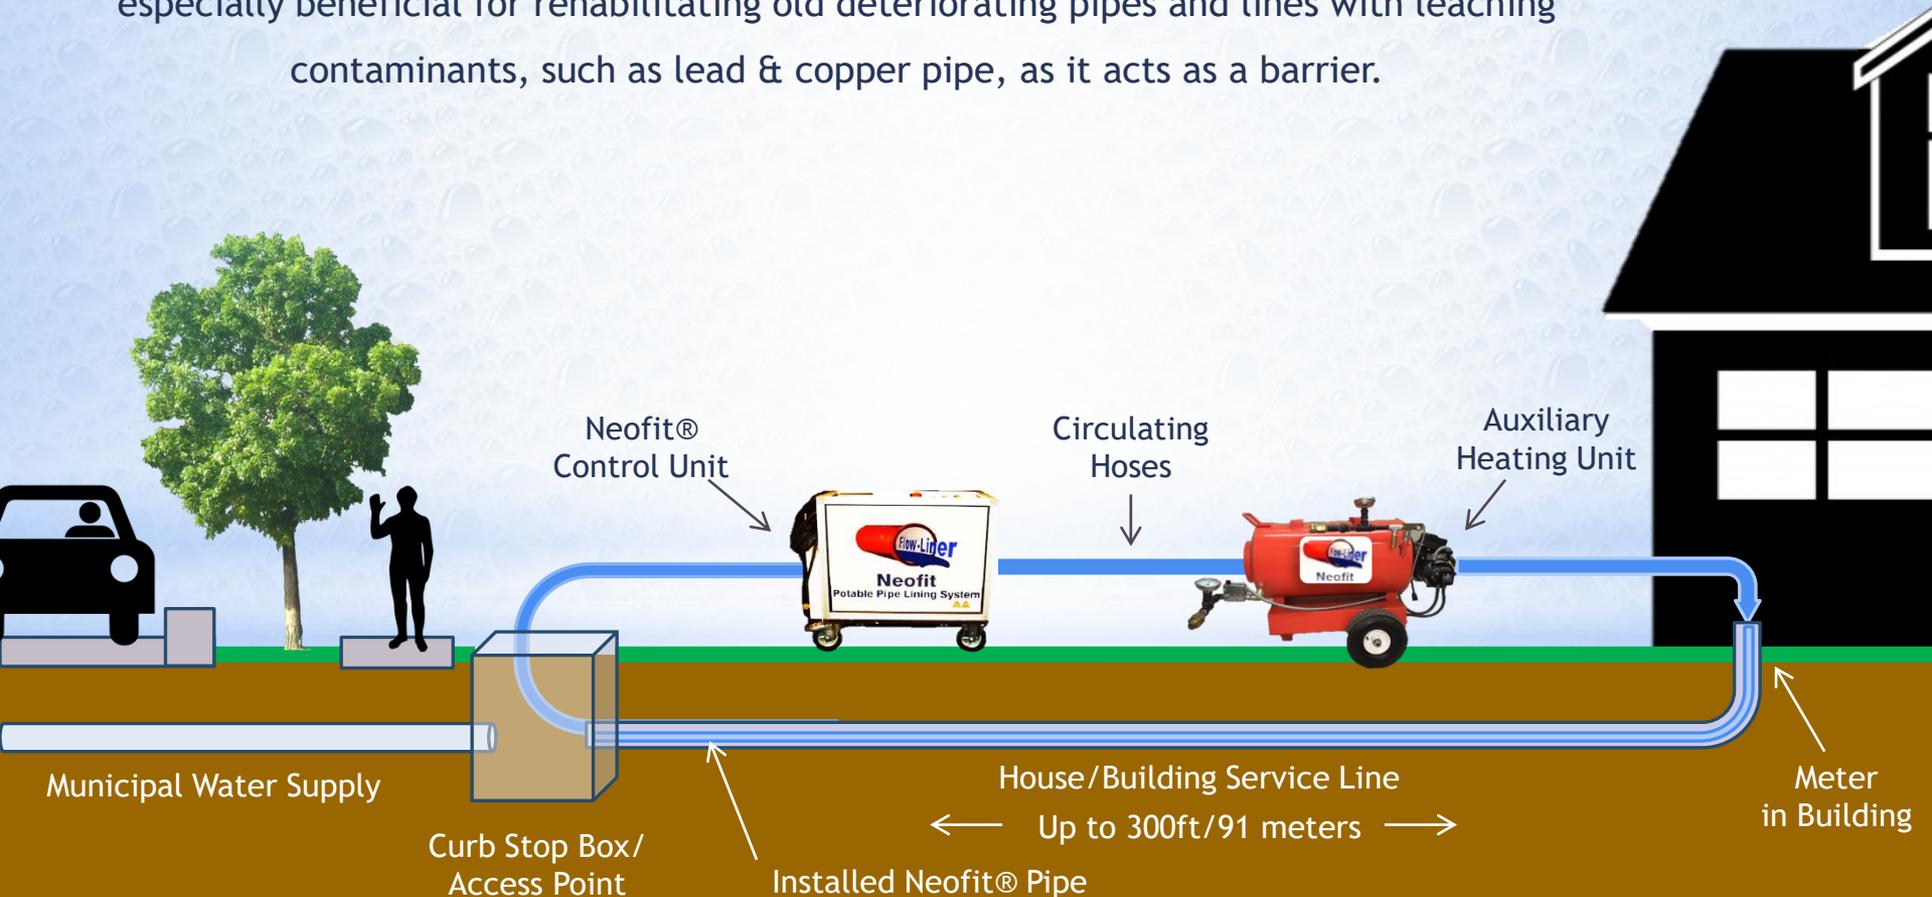
Neofit Basic Installation

The Neofit®+Plus System Is particularly suitable where alternative solutions prove to be disruptive, such as alongside other infrastructure, under road crossings, in congested ground with other utilities, and in customer properties under drives and gardens. It is also especially beneficial for rehabilitating old deteriorating pipes and lines with leaching contaminants, such as lead & copper pipe, as it acts as a barrier.

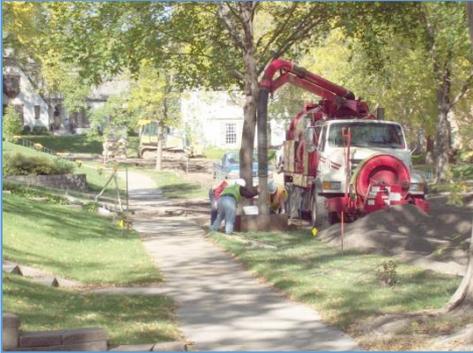
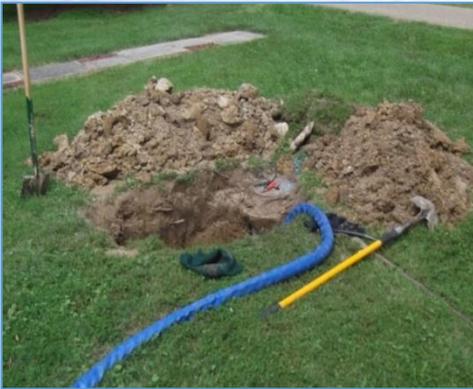
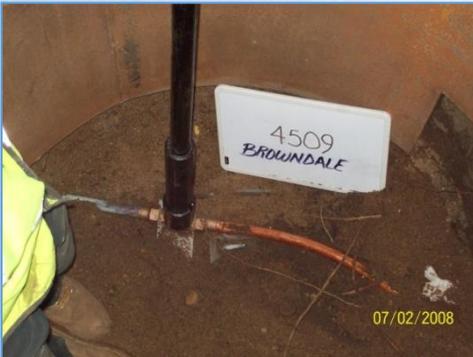
Crew 1

Crew 1- Set-up & Any Necessary Access Pits

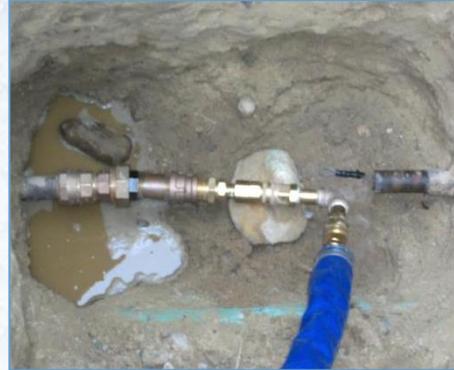
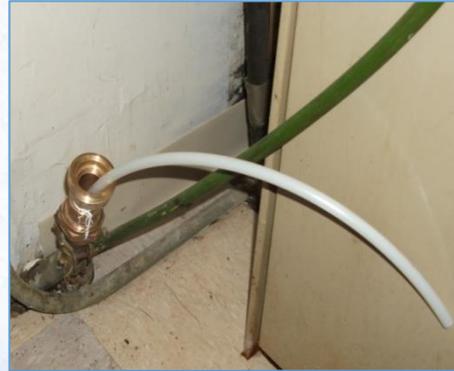
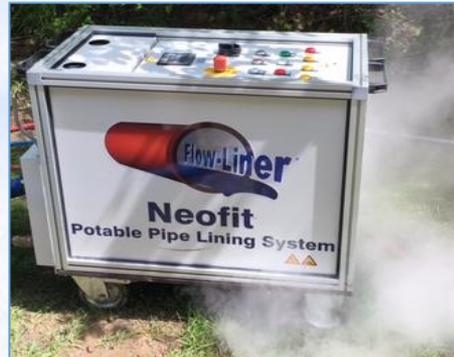
Crew 2

Crew 2- Cleaning, Installing, and Expansion Process

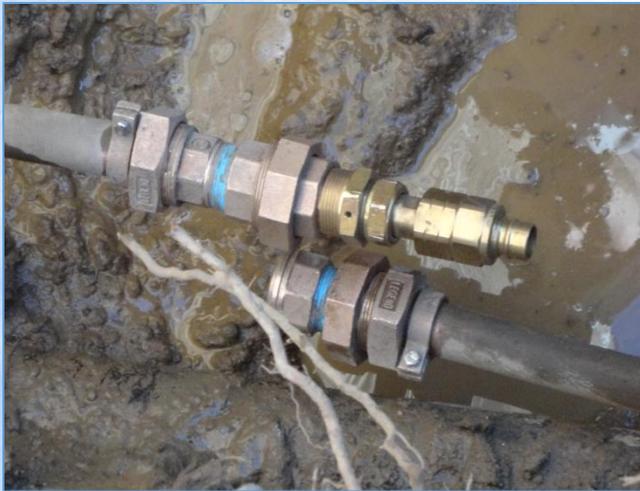
Neofit & Valves

- * Installing at Valves
 - * Can install through an open valve
 - * Valve cannot be closed once Neofit is installed
 - * Install new valve with Neofit
 - * Install new valve at a different location

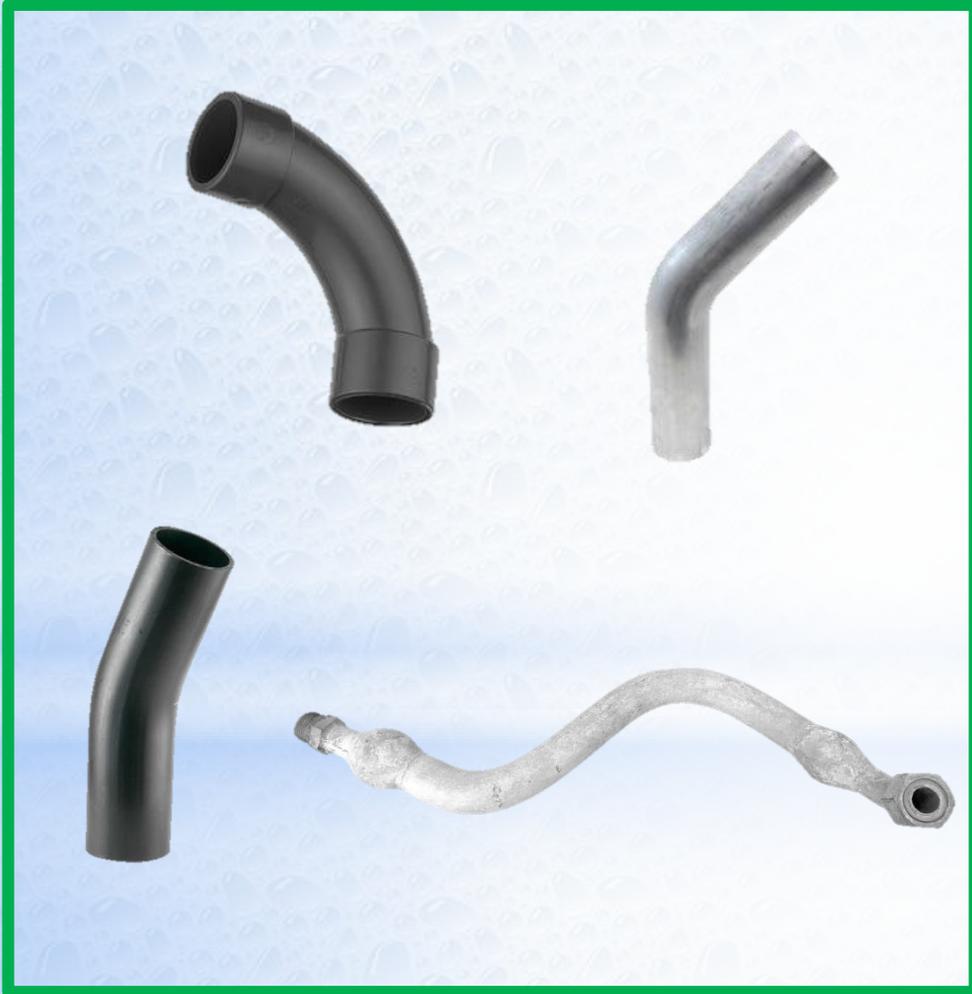
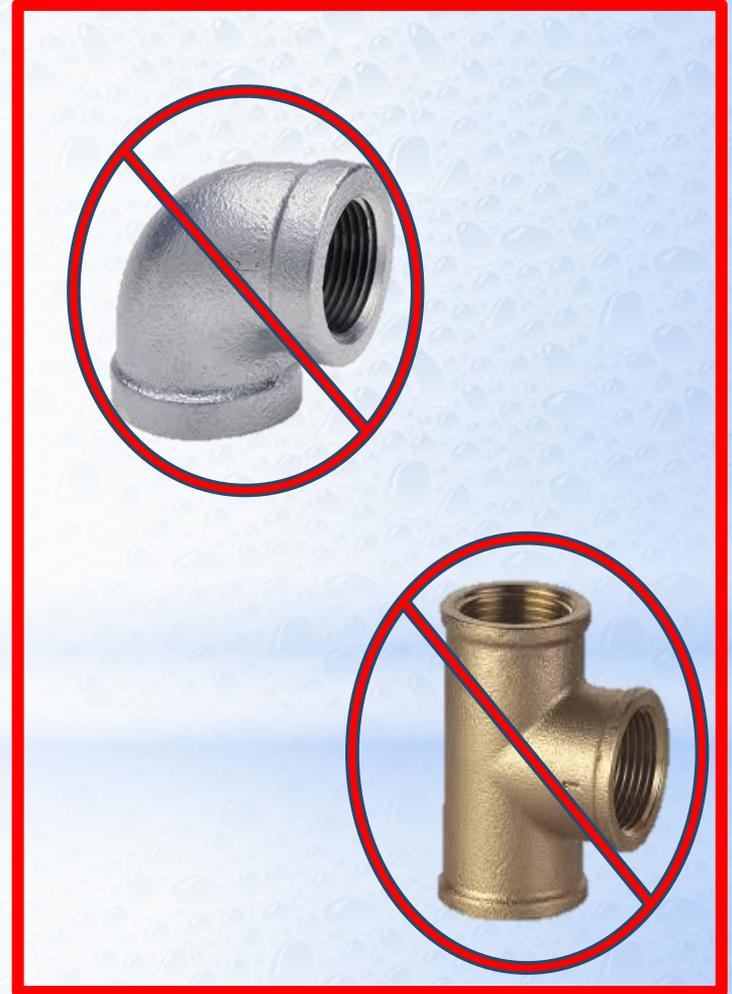
Bends

Acceptable Bends: Long Sweep 90° and $\pm 45^\circ$

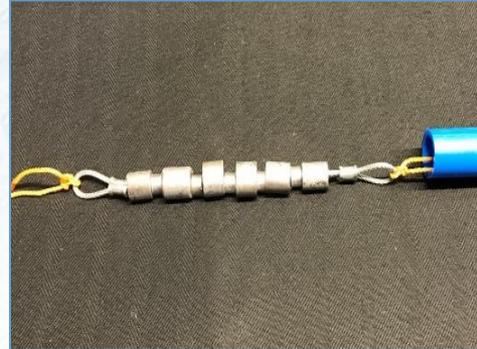
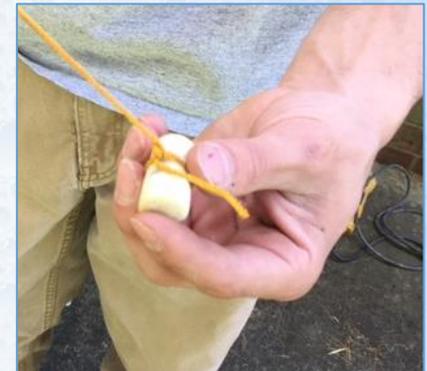
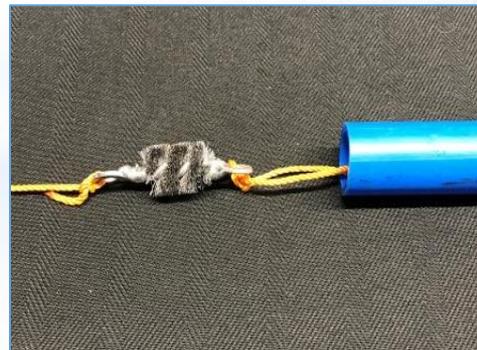
Neofit+ & Cleaning

- * Cleaning Instruments
 - * Mandrels
 - * Brushes
 - * Cleaning Pigs
 - * Jetting
- * Remove Scale Build-Up
 - * Increase inside diameter
- * Clear Obstructions and Sharp Obtrusions
 - * Fins found in some lead pipe
 - * Cuts and damages
- * Cleaning does not need to be as intensive as the sandblasting that coatings require. It is best to remove as much scale build-up as possible for the same reasons you would want it removed with or without Neofit pipe, increased diameter for increased flow capacity.

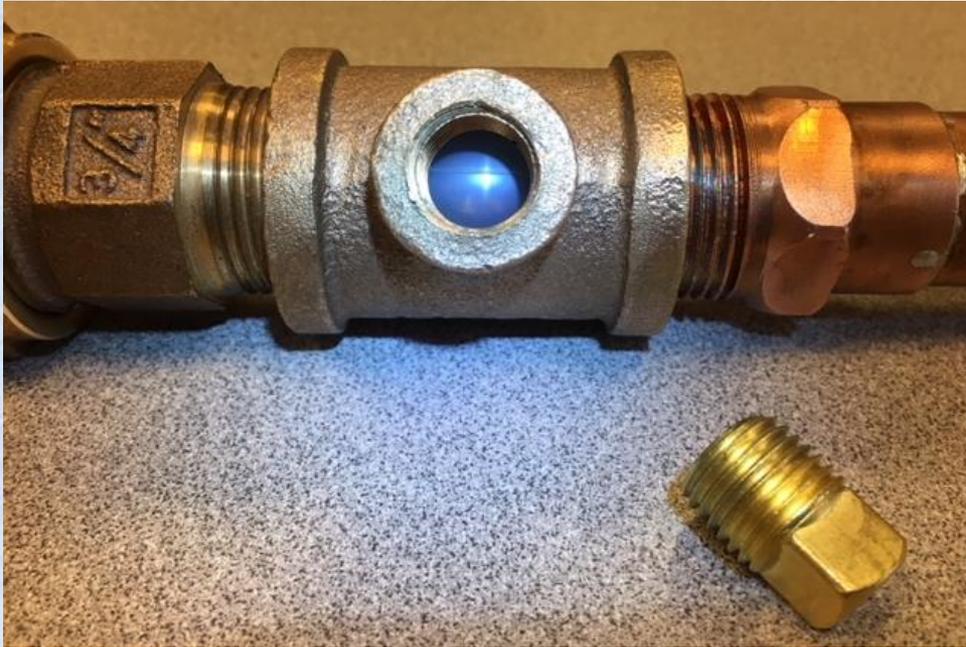
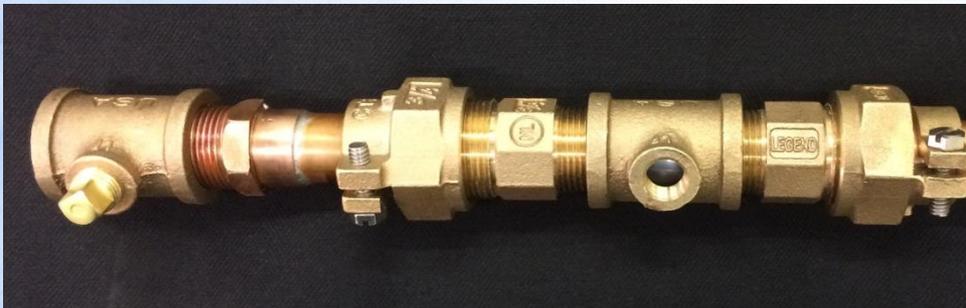
Neofit+ Liner Integrity Test Ports

- * **Test Ports** (when required)
 - * Test ports have 3 uses
 - * 1) Test ports assist with tracer wire which is used when installing Neofit in smooth plastic pipe to help purge excess air during the expansion process and to trace underground water service piping
 - * 2) Test ports act as a final confirmation that expanded pipe is not leaking
 - * 3) In lead or copper lines, an additional test port would be installation to be used for water sampling and contaminate testing

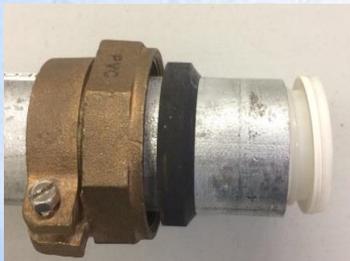
1) Neofit®+Plus End-Seal™ Repair Fitting

An insert fitting to be used in conjunction with AY McDonald and Ford Compression fitting

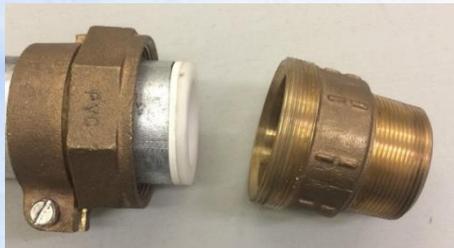
2) Neofit®+Plus Reflaring Kit™ (Patent Pending)

After cutting back the pipe, and exposing the expanded Neofit® pipe, a heated expansion tool begins expanding the liner out against a new compression coupling. The pre-heated flaring tool will finish the expansion, beveling the edge of the expanded pipe against the fitting.

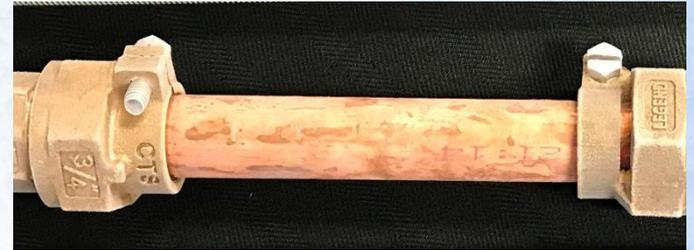
- * Figure 1 depicts a $\frac{3}{4}$ " copper pipe with Neofit® installed and frozen for 48hrs. Shows no signs of damage to pipe.
- * Figure 2 depicts $\frac{3}{4}$ " copper pipe **without** Neofit® and frozen for 48hrs. Notice the split in the copper pipe near the fitting.
- * Figure 3 depicts $\frac{3}{4}$ " PEX tubing with an approx $\frac{1}{4}$ " hole drilled in it and then protected with Neofit. Pipe frozen for 48 hrs. Shows no signs of damage to pipe or any breach where hole is drilled

- * Conclusion: Pipes protected with Neofit were not damaged when frozen. Neofit added strength to host pipe and protected from splitting as show in figure 2

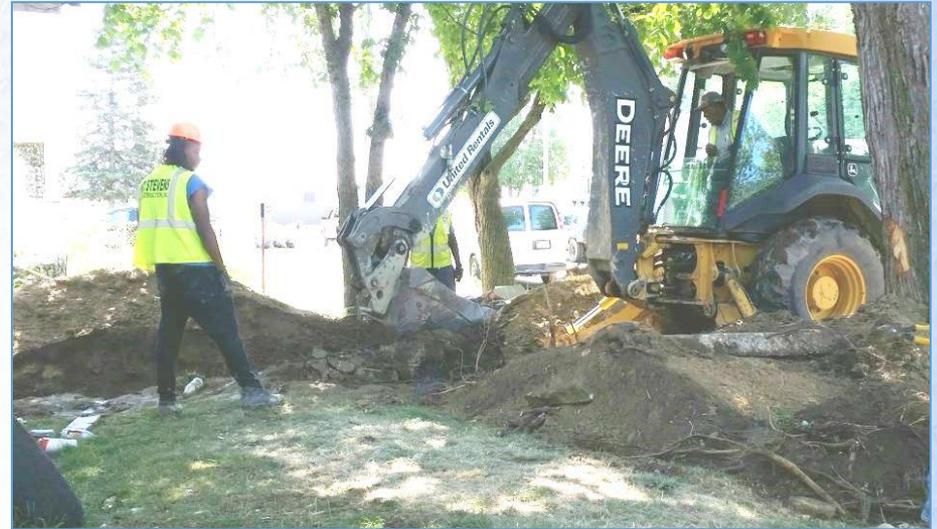
* Lead Service Line replacement (Flint)

- * Extremely Invasive
- * Damaging
 - * Surrounding Utilities
 - * Landscaping, Lawns, Driveway, Sidewalk, Road

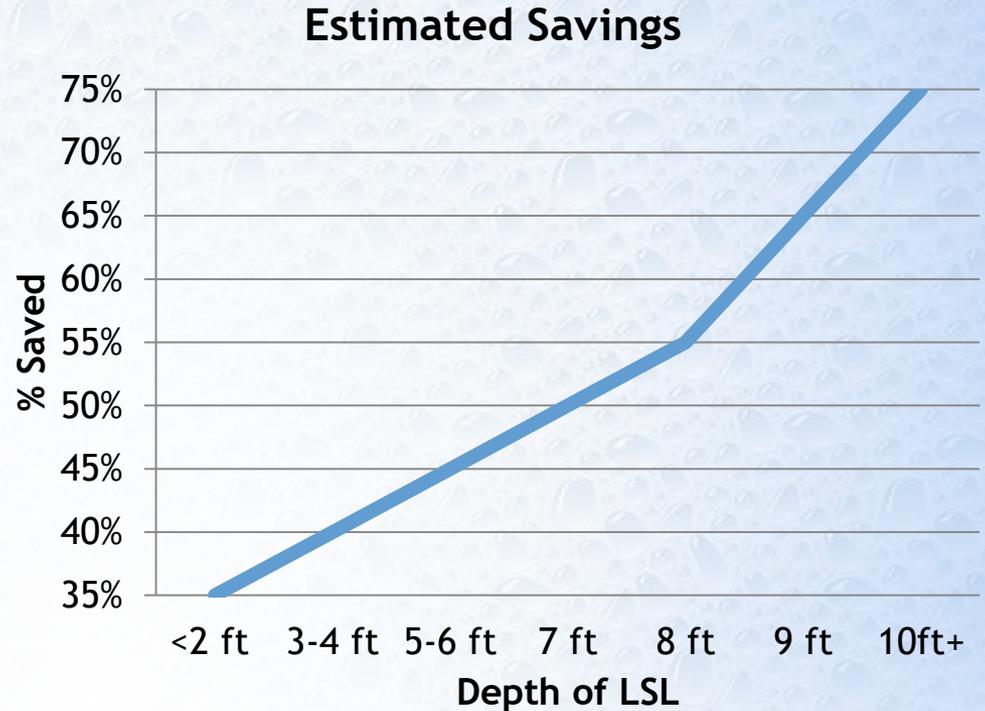
- * Average savings estimated at 35-45%
- * As depth or length of line increases, so does your savings

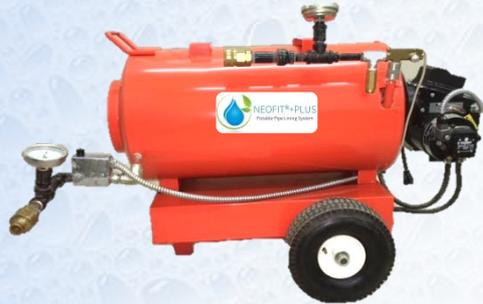
Neofit®+ Plus Unit Specifications

- * For Pipe Sizes: -- 1/2" - 2" ID (U.S.)
- * For Pipe Types: -- Lead, Plastic, Copper, Galvanized
- * Operation: -- Automated Controls
- * Electrical: -- 208V; 60HZ; 3PH
- * Hot Water Unit: -- Auxiliary Diesel Fired
- * Weight: -- 310lbs
- * Dimensions: -- 36" H x 19" W x 40" L
- * Hoses: -- 25' Sections w Quick Connect Ends (8)
- * Lining Capacity: -- Up to 300 lineal feet

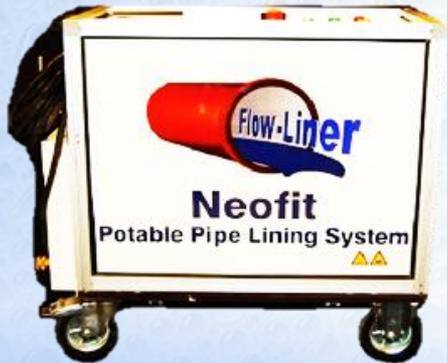
- * Includes: Hoses, Quick Connect Adapters, Hot Water Unit, Air Gun, Coil Dispenser

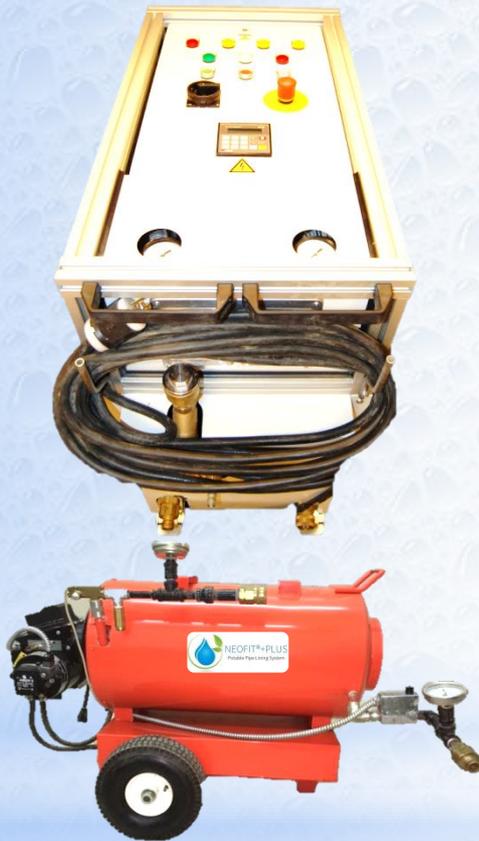
Neofit®+ Plus Standard Installation Package for ½” - 1” ID pipes
